# BOTCHERGATE CONSERVATION APPRAISAL AND MANAGEMENT PLAN

JULY 2012

CARLISLE  
CITY COUNCIL

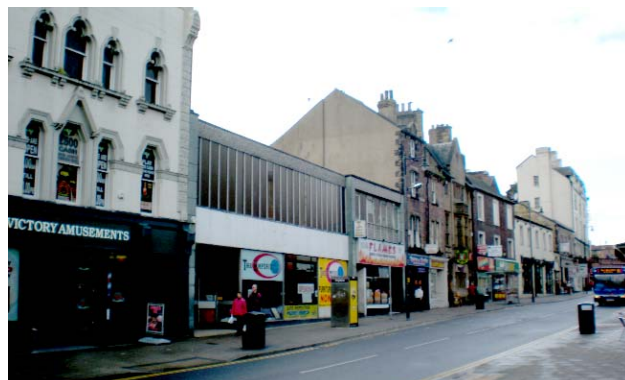
Fig 03. An incongruous 1960s structure, with significant potential for redevelopment.

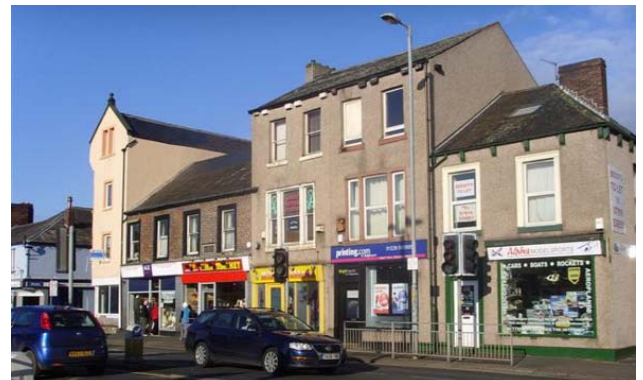
Fig 09. The four storey rendered building marks the beginning of London Road and 'Area 3'

and delicate curved sash windows replaced by PVCu (fig 9).

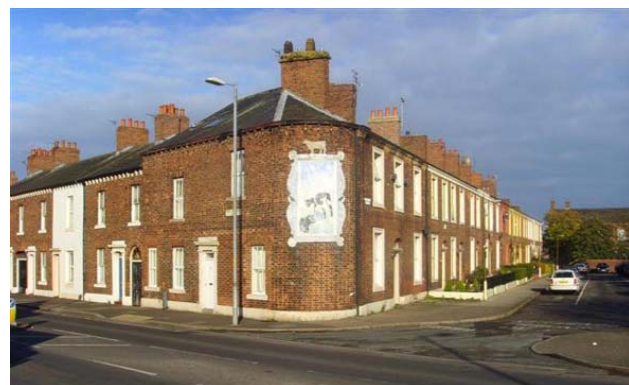
Fig 16. The former public house at the corner of Woodrouffe Terrace and St Nicholas Street.

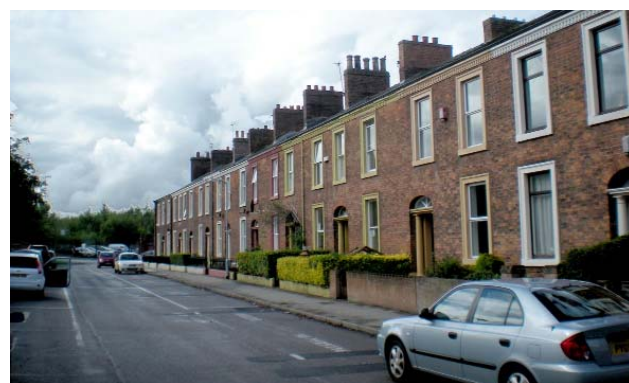
Fig 17. The Grade II listed Woodrouffe Terrace.

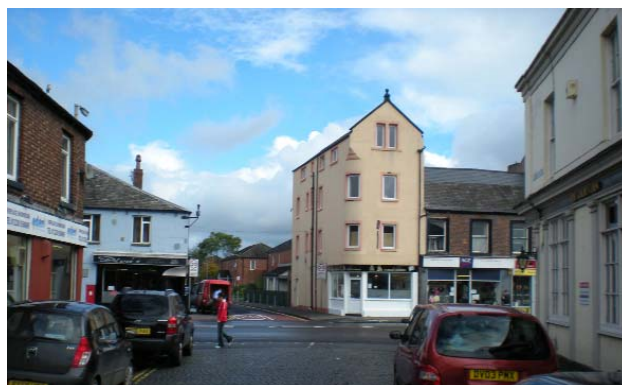
Fig 19. A prominent building at 1 London Road, which has recently has render applied over its original brickwork

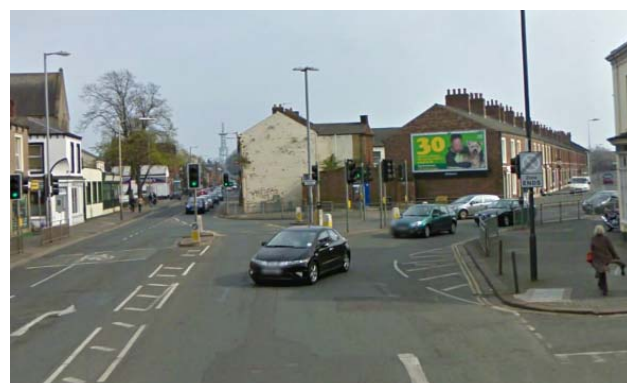
Fig 21. The vehicle dominated junction of St Nicholas Street and London Road.

Christ Church gardens and the St Nicholas St junction referred to above. At present these areas are underwhelming but an appropriate landscape / architectural intervention could create focal points and vistas of note.

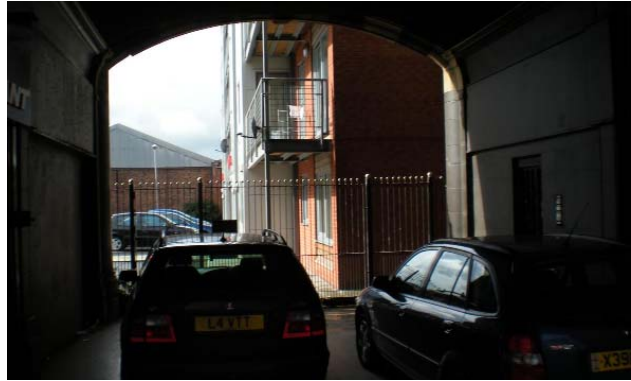
1.7.2 A recent example of a missed opportunity to utilise a vista to the mutual benefit of both the streetscape and the development is the interface between the recent 'picture house apartments' and the large carriage arch set within the Palace Arcade. The new building nudges apologetically into view through the arch when it could have been designed as a complimentary element (fig 23).

Fig 23. New apartments seen through the arch of the Palace Arcade.

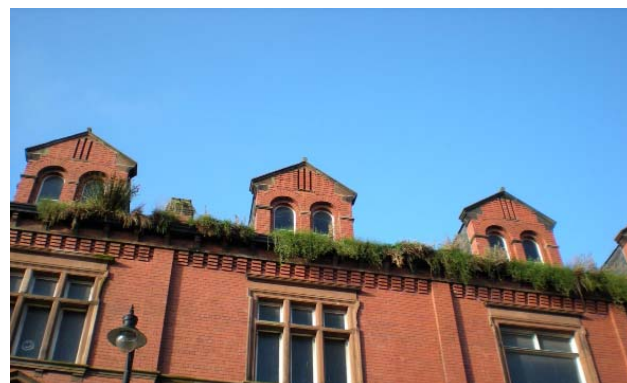
Fig25. Neglect of basic maintenance in the former Boustead's building, latterly Mood's Nightclub.

Fig. 61 The large vacant 'Mood' building could be subdivided to provide smaller retail units with upper floors suitable for residential or office space.

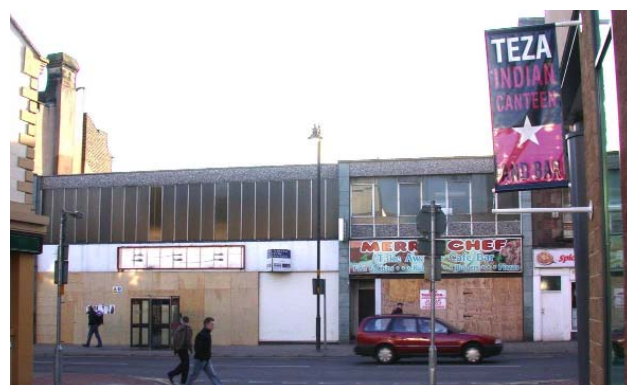
Fig 26. An unfortunate 1960s insertion into the otherwise impressive buildings of the northern part of Botchergate.

1.8.2 Area One contains the conservation area's greatest concentration of good quality commercial Victorian/Edwardian architecture. The entire frontage, except for the recent developments at English Gate, and the unfortunate (c1962) 30-34 Botchergate (fig 26), are locally listed, with Harry Redfern's Cumberland Inn Grade II listed. The 2000-2003 English Gate Plaza and Ibis hotel development attempt to replicate the scale and rhythm of their Victorian neighbours but are markedly more austere and lack visual richness. They benefit the Conservation Area however in that they have helped to inject new uses into what was a series of vacant and increasingly decaying buildings, spurring investment in their retained neighbours. Design failings within the scheme include the blank elevations that frame the new incidental open space of English Gate Plaza, and the barren car parking behind the new scheme. It is testament to the visual strength of the

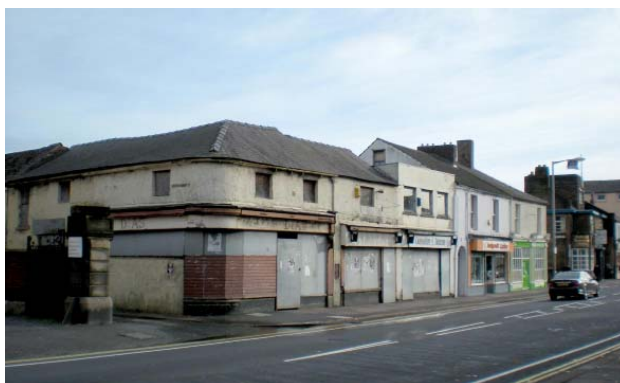
Fig 29. An unimplemented permission exists for this block between Rydal and South Henry Street.

1.8.6 The central part of the Conservation Area is at present the most vulnerable and economically weak. This places its buildings at risk, as lower quality interventions may be considered by owners to be acceptable options. A notable negative influence on the appearance of this area arises from the unimplemented planning consents for comprehensive redevelopment applying to the buildings between South Henry Street and Rydal Street (fig 29). Notwithstanding this permission the buildings themselves are of some modest

architectural interest, in particular the low two storey building at 149/151 Botchergate, (fig 26) - in part as a result of benign neglect its shop front has been retained. This block could be revived sympathetically and allowed once again to contribute to the quality of the street if the currently proposed demolition and comprehensive redevelopment were not to be enacted.

2.6.2 Remaining opportunities include the unimplemented permission for the block between South Henry Street and Rydal Street, although as noted above these buildings could be reinvigorated without demolition.

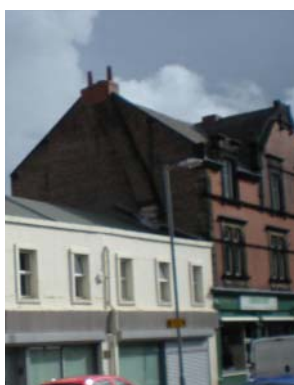
Fig 30. Truncated chimney stack to the Stanley Hall.

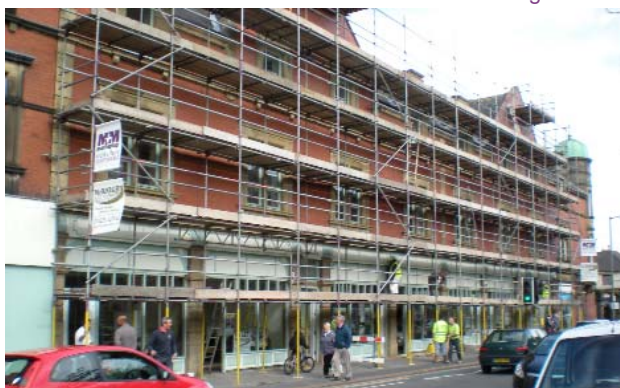
Fig 32. Great improvements to the appearance of Stanley Hall were made by McKnight's builders in 2011.

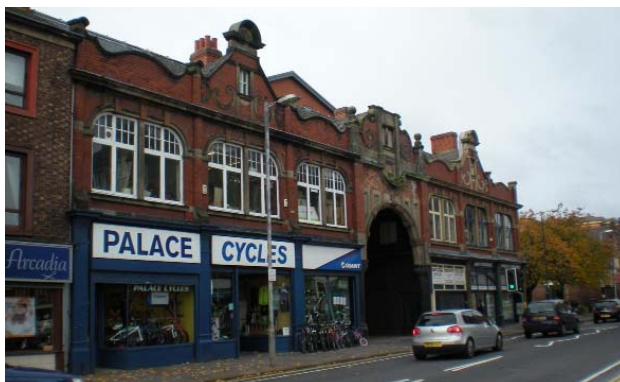
1.8.8 Opposite this building is the Palace Arcade. The building shows a broadly successful approach to its shop frontage in the northern portion, (fig 33) where the 'Gary Etherbridge' unit spans three bays but in subtle and attractive manner. The southern 'palace cycles' signage is much more dominant and unnecessarily large. Neither occupier benefits aesthetically from the security shutters which could be located more sensitively behind the glazing. The Palace Arcade shows examples of the incremental loss of architectural detail - in this case the missing pediment from the central gable, which throws the composition of the facade out of balance. With funding this could be reinstated.

Fig 33. The Palace Arcade building - sadly missing a pediment previously located over the central arch.

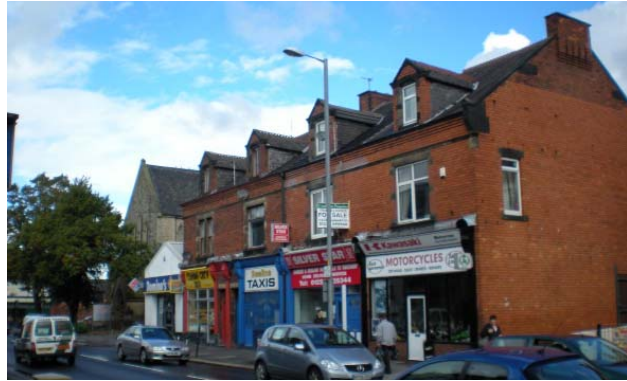
Fig 36. More sympathetic signage and reinstatement of appropriate window designs would lift this row considerably.

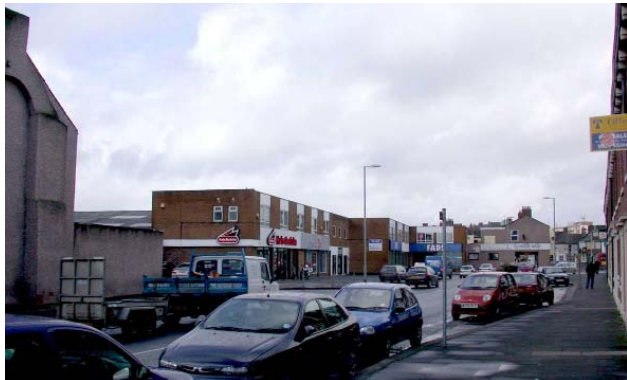
Fig 37. 12-16 St Nicholas Street although outside the conservation area has a negative visual impact on it.

2.2.4 The units at 12-16 St Nicholas Street have a marked detrimental impact on the appearance and vitality of the conservation area. It is likely that the buildings are approaching the end of their design-life, and it is possible that they will be brought forward for redevelopment. It is therefore suggested that the conservation area is redrawn to include these buildings so as to ensure that their replacements contribute positively to their context. This is especially important given the need for future redevelopment to respond sensitively to the listed residential

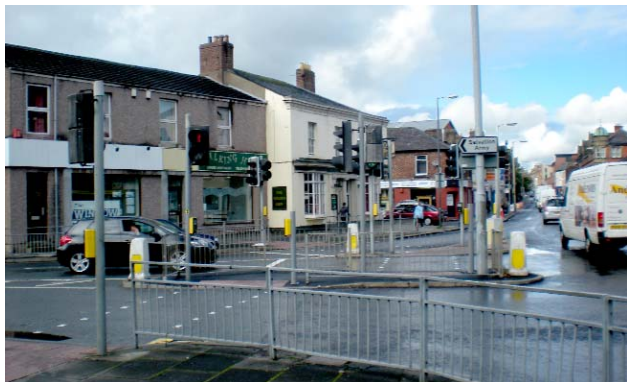
Fig 38. 'Street clutter' at the junction of St Nicholas Street and London Road, impeding pedestrian access and eroding 'sense of place'.

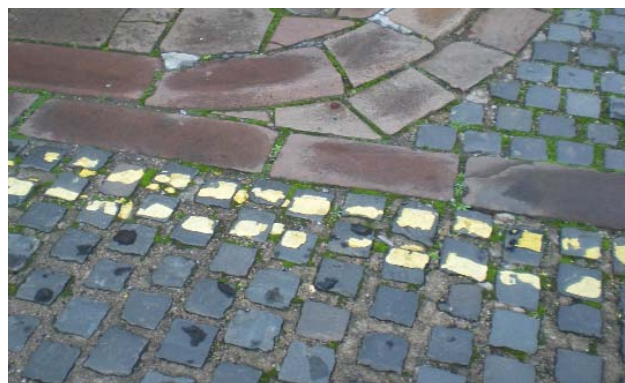
1.9.2 There is more interest however in side streets where there are a number of survivals from the Victorian and early twentieth century. This is a result more of accidental survival rather than a deliberate policy of conservation. High quality basalt setts (fig 40) can be seen on several side streets, in particular on the western side of the Conservation Area which has suffered most from a benign neglect. Princess Street and Albion Street have retained their setted carriageways and despite the loss of their original buildings, this floorscape offers an element of quality around which a new streetscape can begin to develop. In Area One, Collier Lane and Mary Street are similarly paved, although Collier Lane requires extensive restoration due to inappropriate reinstatement following utility works. It is likely that setts may exist under the tarmac on other streets within or adjacent to the conservation area.

Fig 40. Setts and sandstone kerbs and paving at Mary Street.

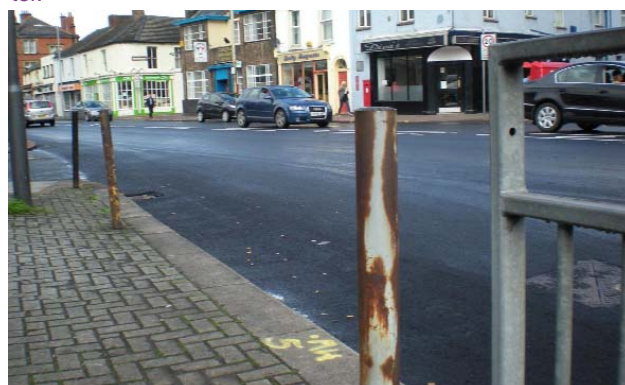
Fig 42. Unsightly bollards and guardrailing close to St Nicholas Street.

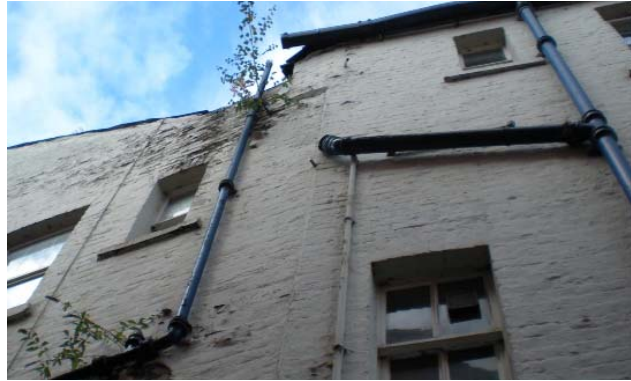
Fig 44. neglected maintenance of gutters leading to vegetation growth and likely damage to building fabric.

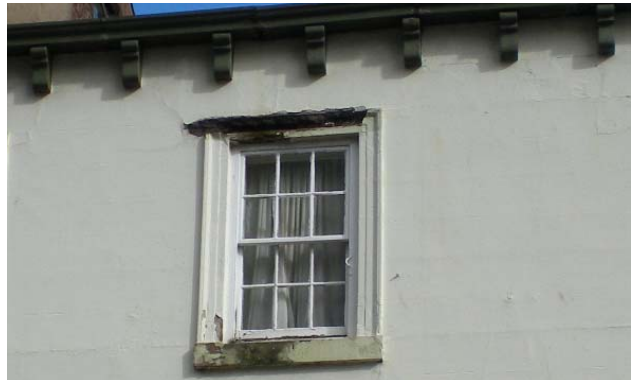
Fig 45. A neglected gutter spilling water onto masonry and window below.

false economy and failure for example to fix leaking gutters or clear debris can lead to expensive structural problems. Fig 45 shows a cracked gutter whose water has spilled on to windows and masonry below, hastening decay and causing potentially costly damage. Figure 46 shows vegetation whose continued growth is likely to damage masonry and allow water ingress into the building.

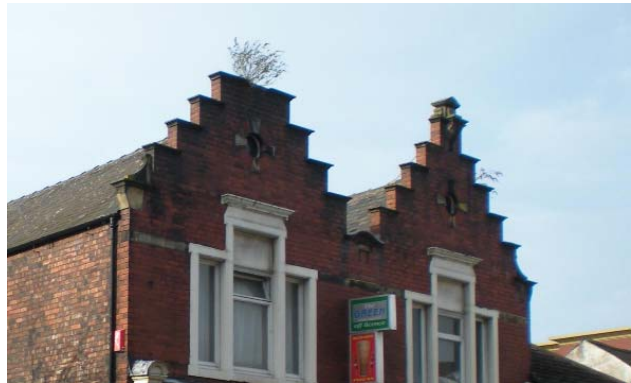
Fig 46. Buddleia growing in coping could eventually unseat the masonry unless removed.

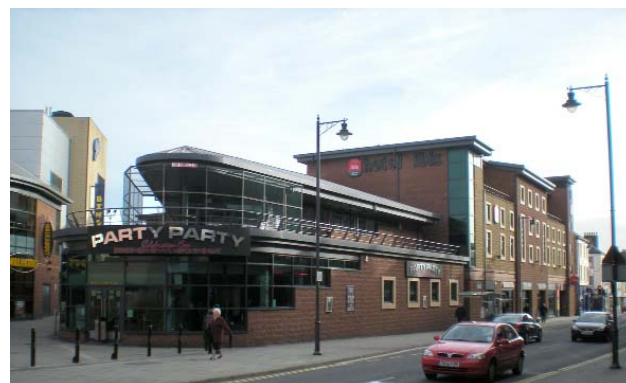
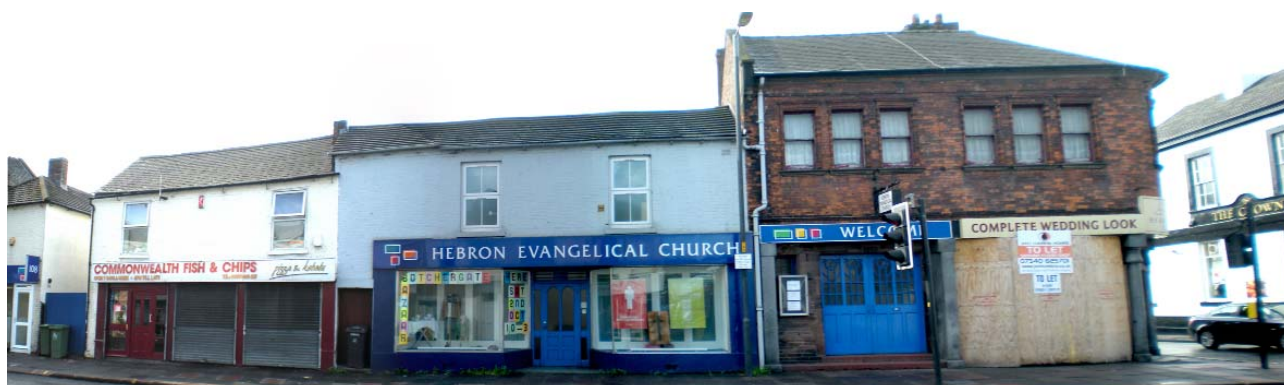
Fig 48. 98-106 Botchergate. These buildings are typical of those which currently border negative/neutral but which could be enhanced through a shopfront enhancement programme.

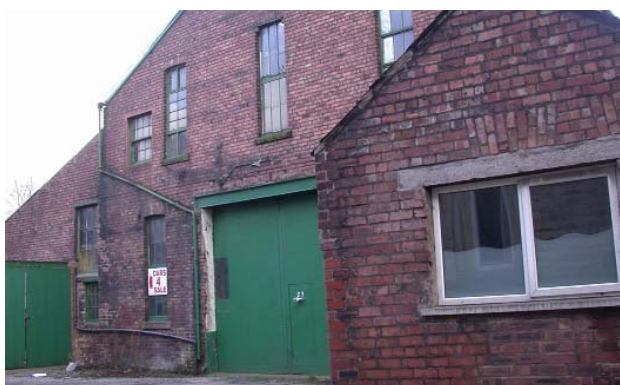
Fig 50. Garage building at 27-29 London Road. A potential development site but not readily visible from within the conservation area.

mainly visually separated from the Conservation Area by the terraced frontage to London Road. It is likely that development on this site will not be visible from the Conservation Area. For this reason it is not recommended that the site is brought within the conservation area boundary.

2.2.2 It could be argued that there are several sites adjacent to the Conservation Area whose development might adversely impact upon it and that the boundary should be modified to include these. Such sites include the garage complex at 27-29 London Road (Fig 50), the 1960s development at 12-18 St Nicholas Street and the area abutting Christ Church Gardens.

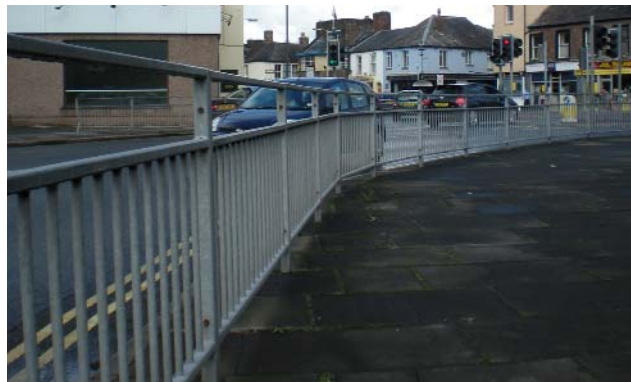
Fig 55. Guardrailing at St Nicholas Street.

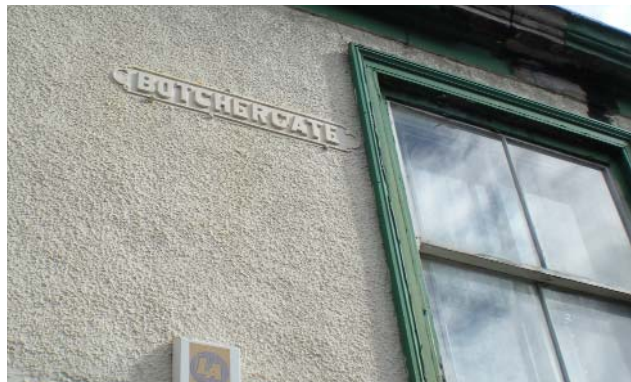
Fig 56. A cast iron street nameplate which could readily be restored, adding some quality to the streetscape.

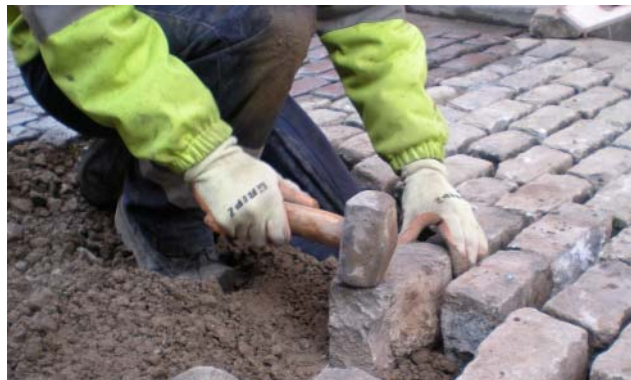
Fig 57 Restoration of Setts on Collier Lane.

2.3.2 Other elements of note exist in the retained historic surfaces to Collier Lane, Mary Street and other side streets which retain their setted surfaces. These high quality basalt setts are an integral part of the character of the conservation area. Wherever possible they should be retained and reinstated where they have sustained damage (e.g. in sections of Collier Lane damaged by utility trenching). The protection of these surfaces should extend along the length of those streets which adjoin the Conservation area e.g. King Street and Princess Street - in these cases they offer an element of public realm quality which can be used to enhance future built-development.

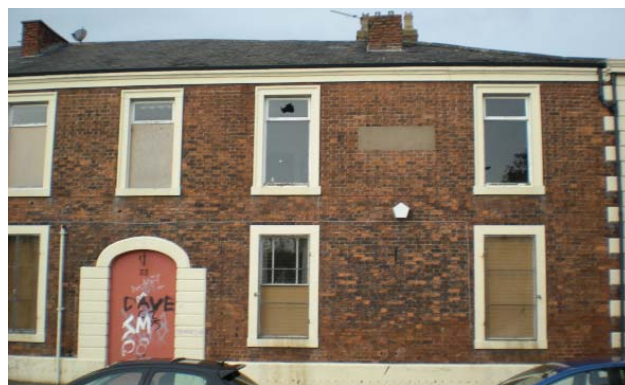
Fig 58. Unoccupied former surgery at Woodruffe Terrace, suffering casual vandalism.

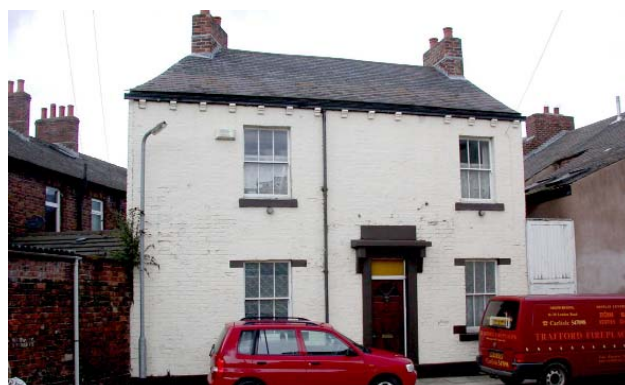
Fig 59. An unlisted building on Blake Street retaining its original windows and contributing strongly to the quality of the area.

servation area are largely retail or other uses which do not enjoy permitted development rights. Much of the incremental loss of architectural elements in these buildings will require planning permission. It is therefore not likely that an Article 4 direction would be of benefit to the Botchergate Conservation Area, unless it is to address the handful of remaining residential properties which retain historic architectural detail such as the sash windows at No 1 Blake Street (fig 59).

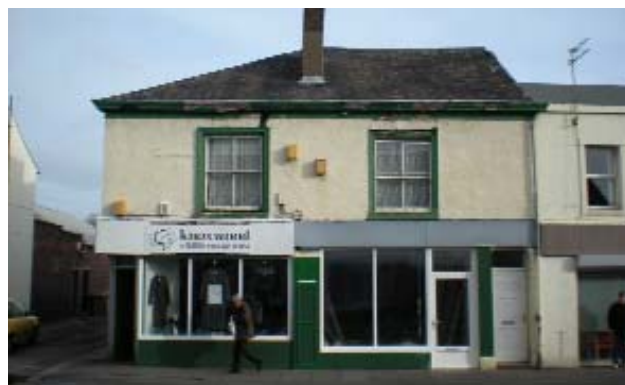
Fig 60. 107-109 Botchergate which although having lost their original shopfronts, retain original sash windows capable of refurbishment.

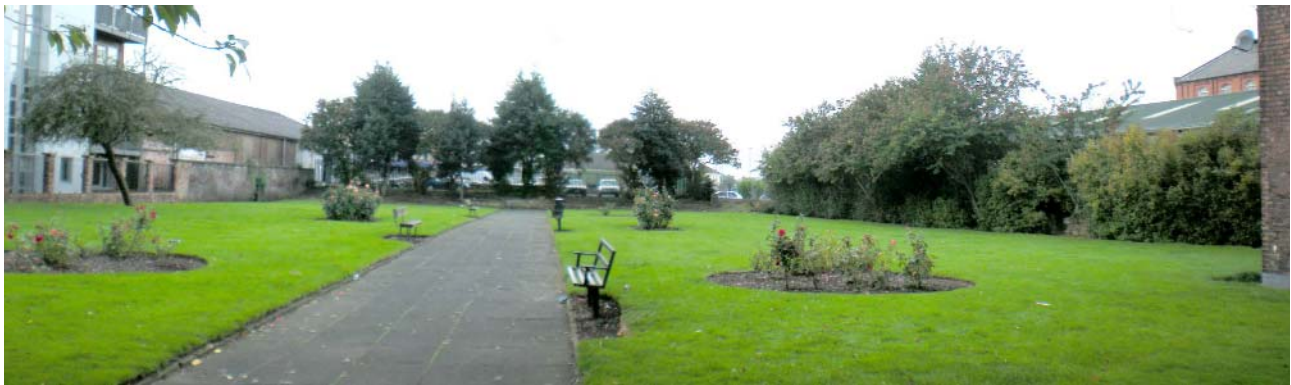
Fig 62. Christ Church gardens - currently an undercapitalised asset. To work effectively, green spaces must have routes passing through or around them, and be well overlooked. The space currently has none of these attributes.

2.2.5 The sole significant open space in the area is Christ church gardens. While it has been improved moderately by the construction of new apartments immediately adjacent, these have failed to capitalise on their neighbour and there is no active connection between the two. The remaining boundaries to the park are currently a small surface car park and two warehouses. The redevelopment of any of these uses offers the opportunity to significantly enhance the park. The risk of development adversely affecting the park is also high, and as such it is suggested that portions of the adjacent building plots are brought within the revised conservation area boundary.

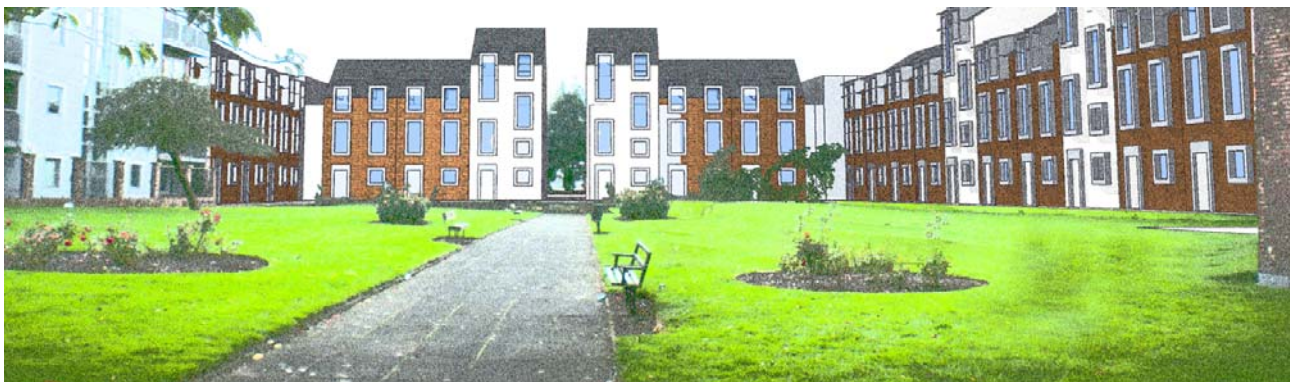
Fig 63. There is potential for new residential/mixed use development in the area which could be focused on the Gardens, with a new access broken through onto Lancaster Street (indicative illustration only).

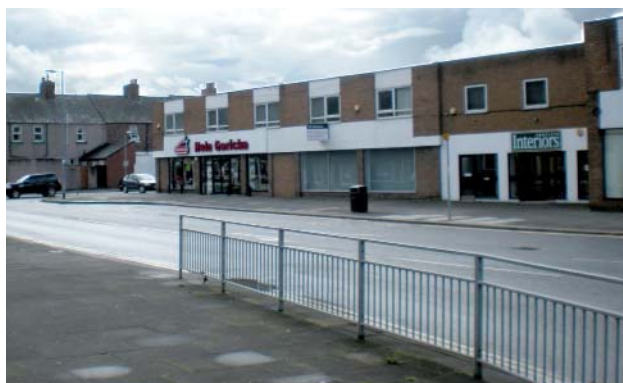
Fig 64. 12-18 St Nicholas Street - although outside the current conservation area is a site whose enhancement would be of great benefit to the wider area.

2.6.5 The 1960s block at 12-18 St Nicholas offers a further opportunity site, which if combined with surface parking to the rear and adjacent sites, offers a significant development opportunity. Development here should have regard to neighbouring residential properties, but the width and depth of the site allows for a substantial development footprint that could revive the fortunes of this part of

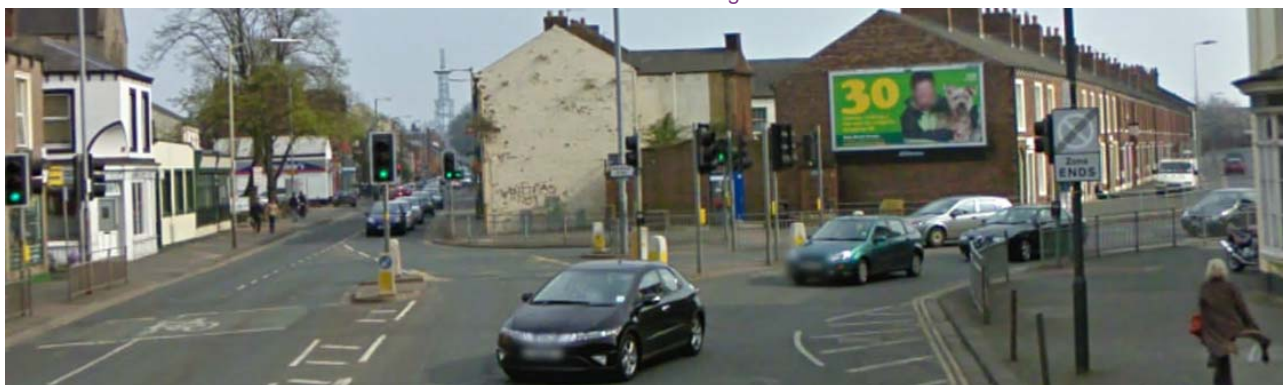
Fig 65. The junction of St Nicholas Street, London Road and Botchergate. Pedestrian movement and the aesthetics of the area are extremely compromised at present by the primacy given to road traffic.

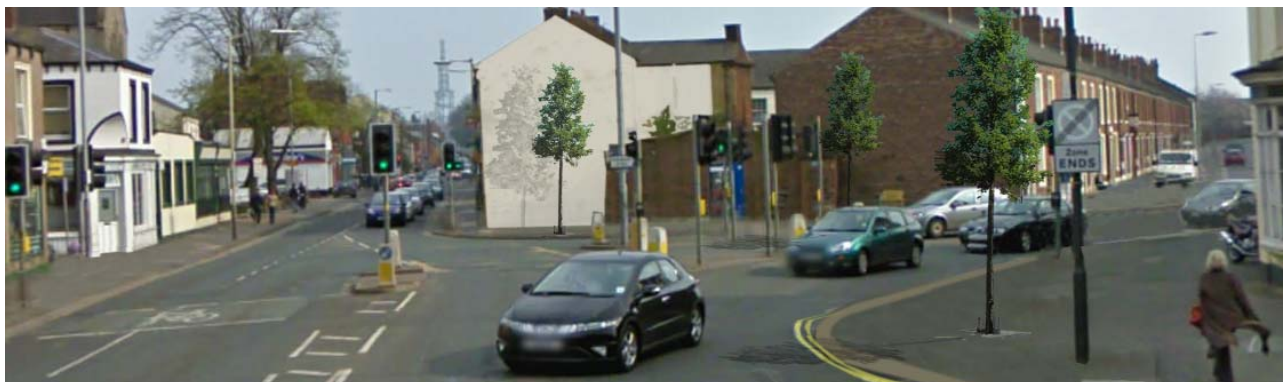
Fig 66. A number of possibilities exist to improve the streetscape through expansion of the pavement, decluttering and appropriate planting (Illustrative purposes only).

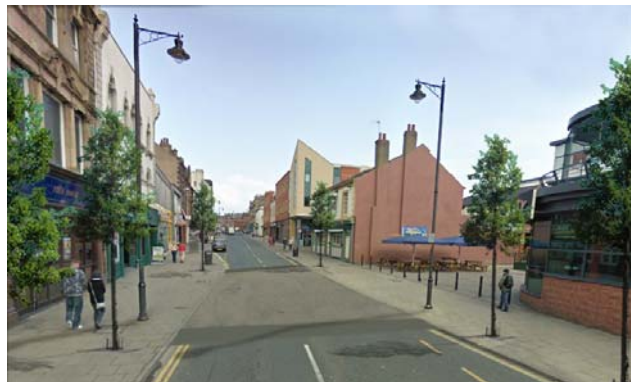
Fig 68. English Gate Plaza is a potential site for a public realm scheme to return space to the pedestrian and soften the hard urban landscape through avenue tree planting.

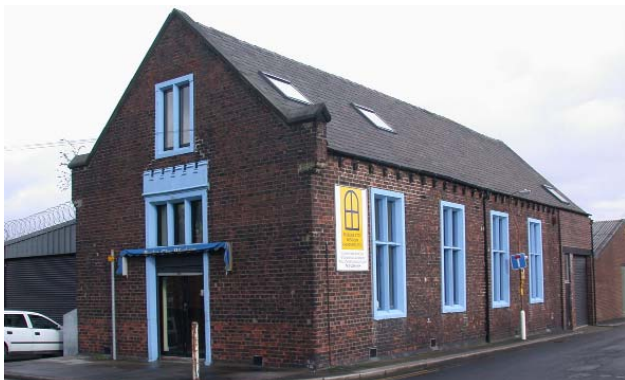
Fig 69. Former Working Men's Reading Room, Lord Street, opened in 1851. A rare survival from 1970's clearance of the Lancaster Street area.

2.6.8 Some buildings of note remain within this area including the reading room at the western end of Lord Street; the Pagoda building, which is a distinctive post-war building, and indeed some surviving remnants of terraced housing at the western ends of King Street and Princess Street

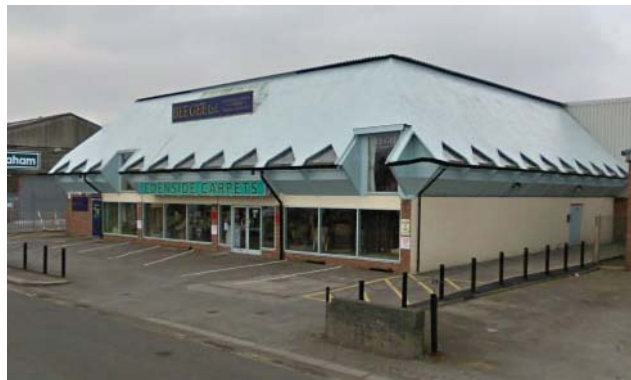
Fig 70. The former Pagoda building, a 1970's office for Olivetti by Ted Cullinan Architects, now Edenside Carpets, is of some interest as a distinctive 20th Century building.
